## Case Study: Christleton Pool Undergoes Filter Refurbishment

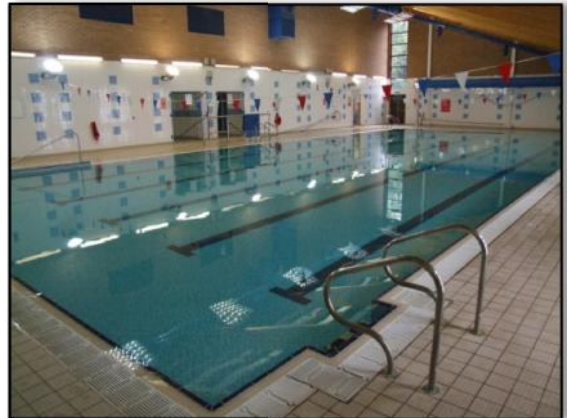
Christleton High School in Chester boasts a 25m swimming pool (right) amongst its facilities and recently the pool experienced problems with sand getting into the pool. Total Pool Chemicals Ltd were called in to assess the problem and immediately the engineer inspected both filters that were in operation. On opening the filters he discovered an uneven sand bed in each filter. This along with the sand in the pool indicated that there was almost certainly some damage to the laterals at the bottom of the filters.

Following the inspection, Total Pool was given the job of refurbishing the filter and examining the laterals more closely. To begin with the team of engineers emptied the existing sand from both filters. Once both filters were empty they analysed the laterals and as expected there was significant damage to the majority of them. In this instance Total Pool decided to replace each of the 60 laterals in each filter to ensure the problem could be completely rectified.

After replacing all of the laterals EGFM (Eco Glass Filter Media) was then loaded into each filter. Steve Carder of Total Pool explains the reasons why this was used ahead of sand. "EGFM has many benefits over standard filtration sand. It saves on water, energy and chemical bills because it has a smoother particle than sand. It is also more efficient and more durable so you may never need to change the filter media once it has been installed. EGFM is also less dense than sand so 15% less EGFM is needed to fill each filter".

To begin with a layer of grade 2 EGFM which ranges from 1.0mm to 3mm in size, was put on the bottom of each filter. This ensured that no finer material could pass through the laterals. After an adequate layer of grade 2 had been loaded, the remainder of the filter was filled up with grade 1 EGFM which is the equivalent size of filtration sand.

Once both filters had been filled to their required level, the covers were refitted and the filters were backwashed for a prolonged period of time. Finally the filters were re-commissioned and the pool could operate as normal again. Since the filters were refurbished the pool has not experienced any further problems with media getting into the pool.
